**REPORT
ON
ACCIDENT TO AIR INDIA EXPRESS BOEING 737-800
AIRCRAFT VT-AXV ON 22nd MAY 2010
AT MANGALORE**

**GOVERNMENT OF INDIA
MINISTRY OF CIVIL AVIATION**

**NEW DELHI
31st OCTOBER, 2010**

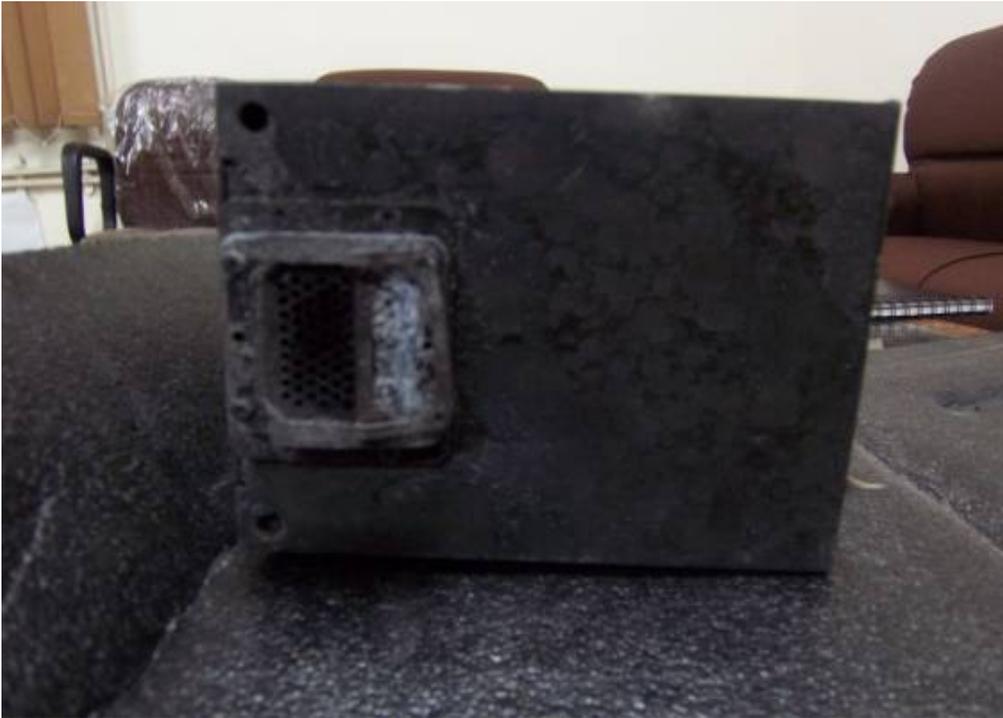
Photo 5: Connector of the CVR Damaged Due to Fire

The CVR had sustained significant heat and fire damage to the exterior as shown below:-

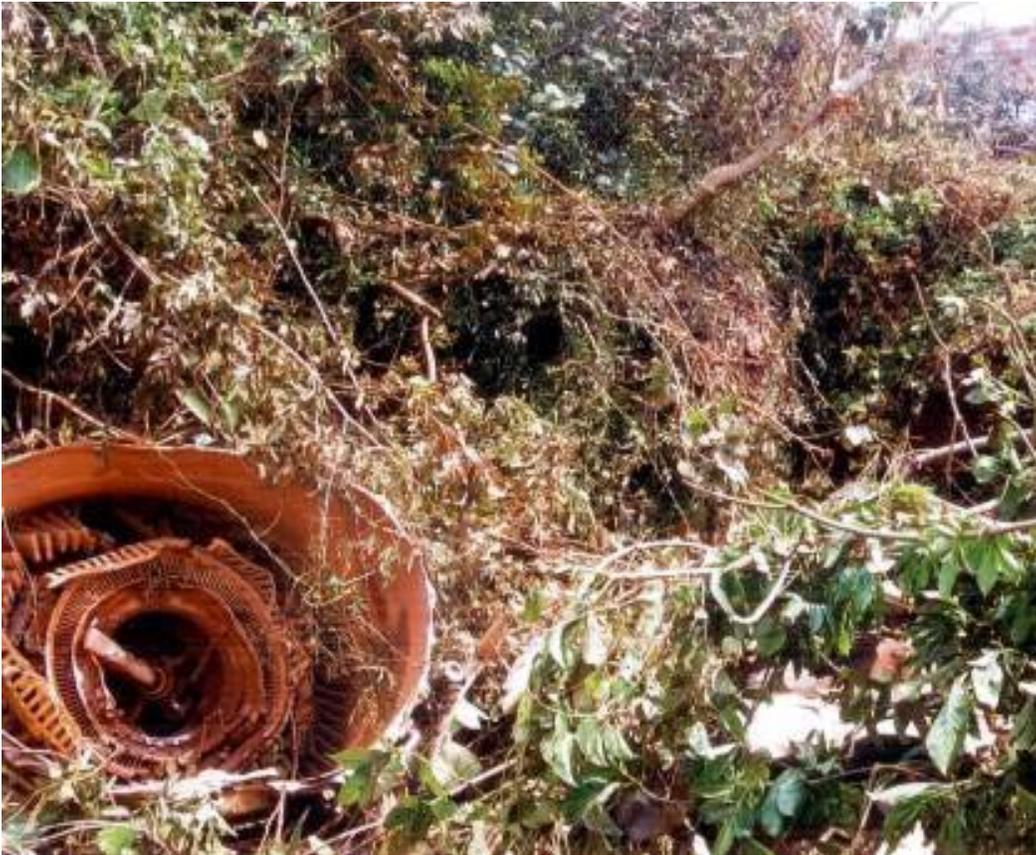
Photo 11: Right Engine lying on the Slope near End of the Airport Fencing

The aircraft then impacted the boundary fence and a portion of the Right wing (from WBL 71.24 to WBL 616.75) containing T/E Flap number 8, L/E Flaps and Slats, was found lying at the edge of the boundary. There were indications of fire visible in this area on the vegetation where the portion of the wing was found. Mangalore being a tabletop runway, the aircraft moved down along the slope of the hill after impacting the boundary fence. A portion of the Right wing, Right engine, Right main landing gear and few other structural parts separated from the aircraft in this area. Due to impact, component/parts of the Right engine also separated. Right engine fan frame, thrust reverser frame, core engine and associated components were recovered on the slope.

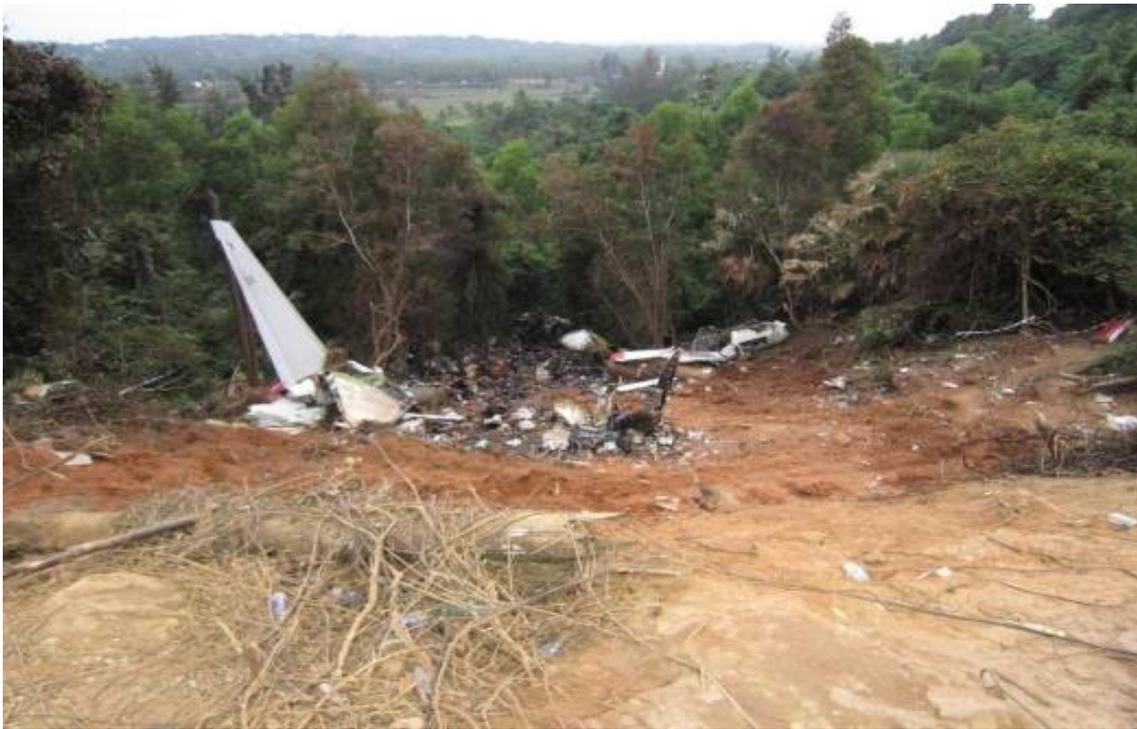
Photo 13: Gorge - The Final Resting Place of Wreckage

At the end of the initial down-slope, there was a road followed by a gorge. The aircraft entered the gorge and separated into three main portions. The aircraft caught fire and a large portion of the aircraft was consumed in the fire. Due to impact and fire, the aircraft was destroyed.

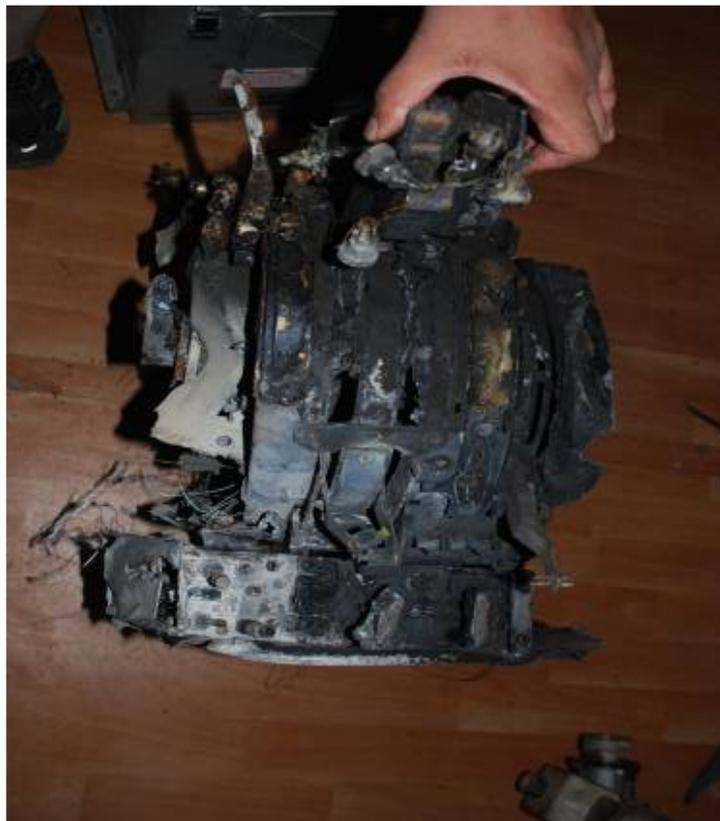
Photo 14: Control Stand

- Landing Gear Lever : Near Down Detent and Jammed
- Thrust Lever : Fully Forward
- Flaps : At Flap 40 detent
- Speedbrakes : Down Detent

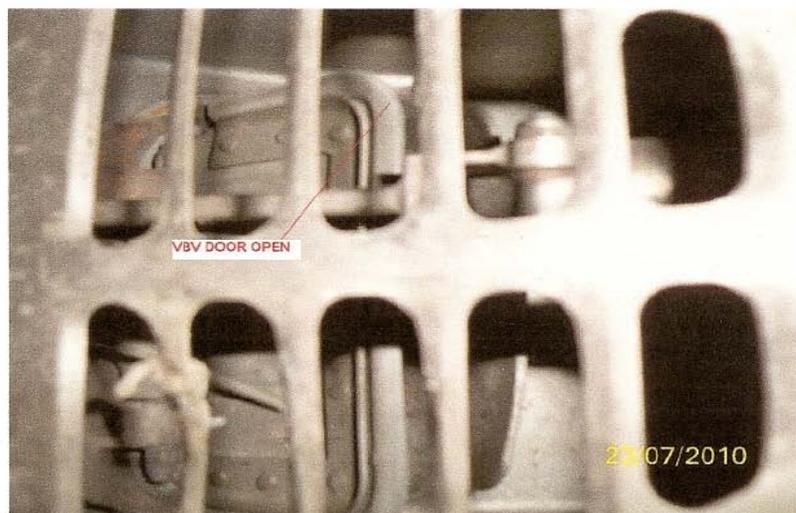
Variable Bleed Valve

1. Inlet cowl removed from the engine as instructed and engine installed on pedestals.
2. Inlet cowl found with impact damages at the forward end causing metal and composite material to liberate and enter into the gas path.
3. Fan frame and spinner cone found with deep dents.
4. All fan blades are found damaged. Some fan blades are observed torn with pieces missing.
5. The N1 and N2 spools of the engine could be rotated.
6. Exhaust nozzle and plug found with impact damages.
7. Variable bleed valves found fully open. Refer photograph below.

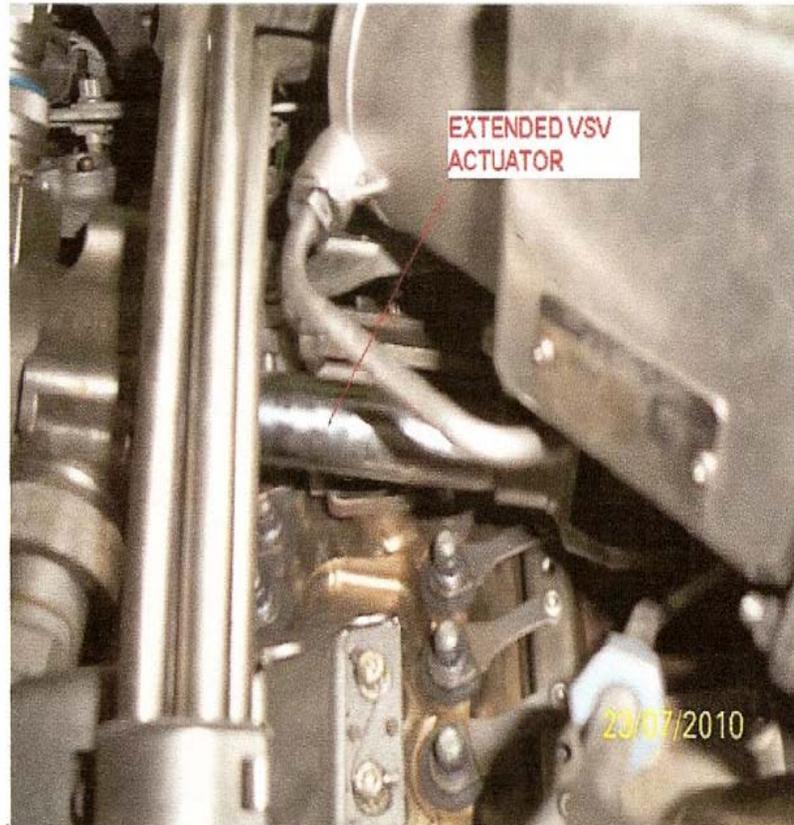
VSV Actuator.

8. Variable stator vane actuators found extended exposing approximately 3.500 inch of actuator piston rod. Refer photograph below.

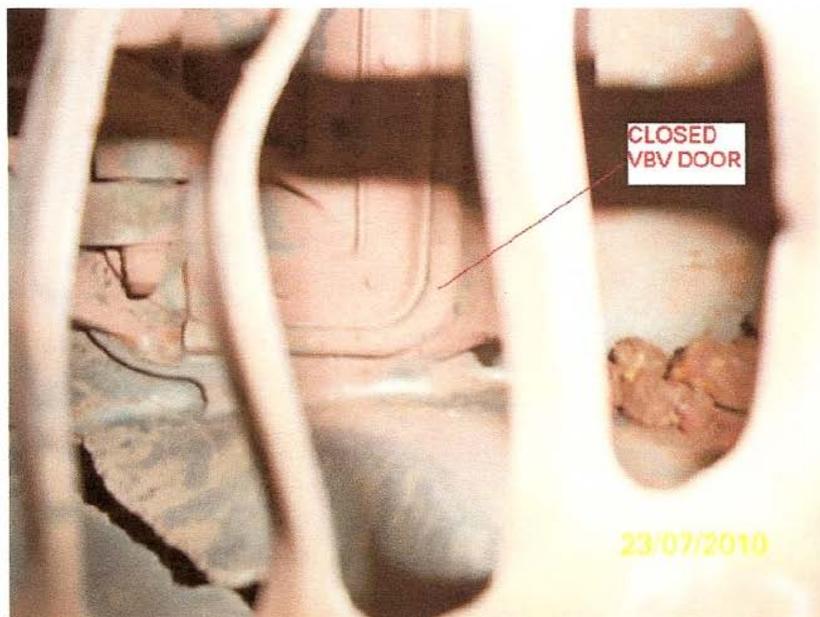
Variable Bleed Valve

1. Fan frame and turbine rear frame found distorted.
2. The forward and aft engine mounts found missing and thrust links found broken.
3. Fan frame observed twisted approx. 90 degree anti-clockwise looking from rear of the engine.
4. Low pressure turbine shaft found broken and the low pressure compressor with fan received as a separate disintegrated unit. All fan blades found sheared off near the root of the blade.
5. The N1 and N2 spool of the engine could not be rotated.
6. Accessory gear box and most of the accessories observed broken.
7. Variable bleed valve doors found closed, bleed ring area found totally distorted. Refer photograph below.

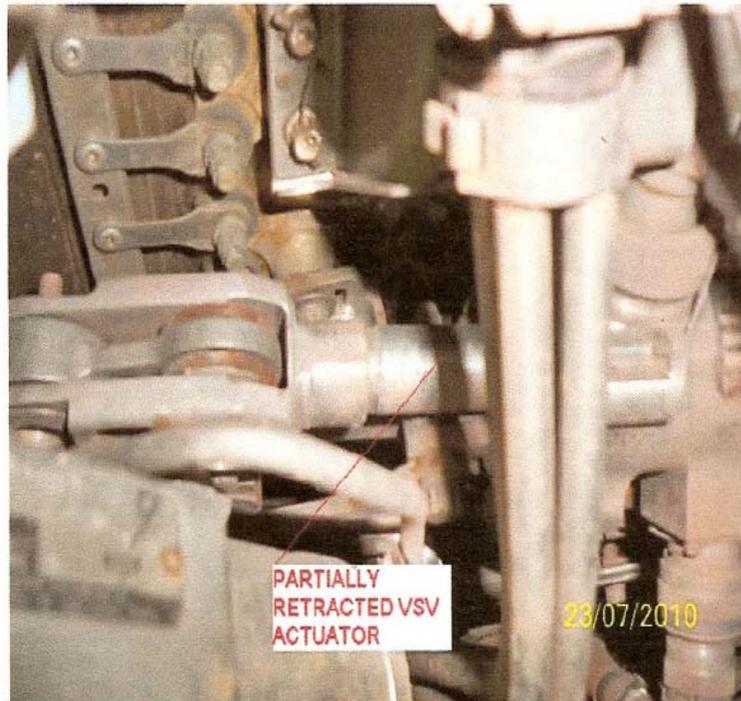
VSV Actuator.

8. Variable stator vane actuators found extended partially. Approximately 1.3 inch of actuator piston rod found extended. Refer photograph below.

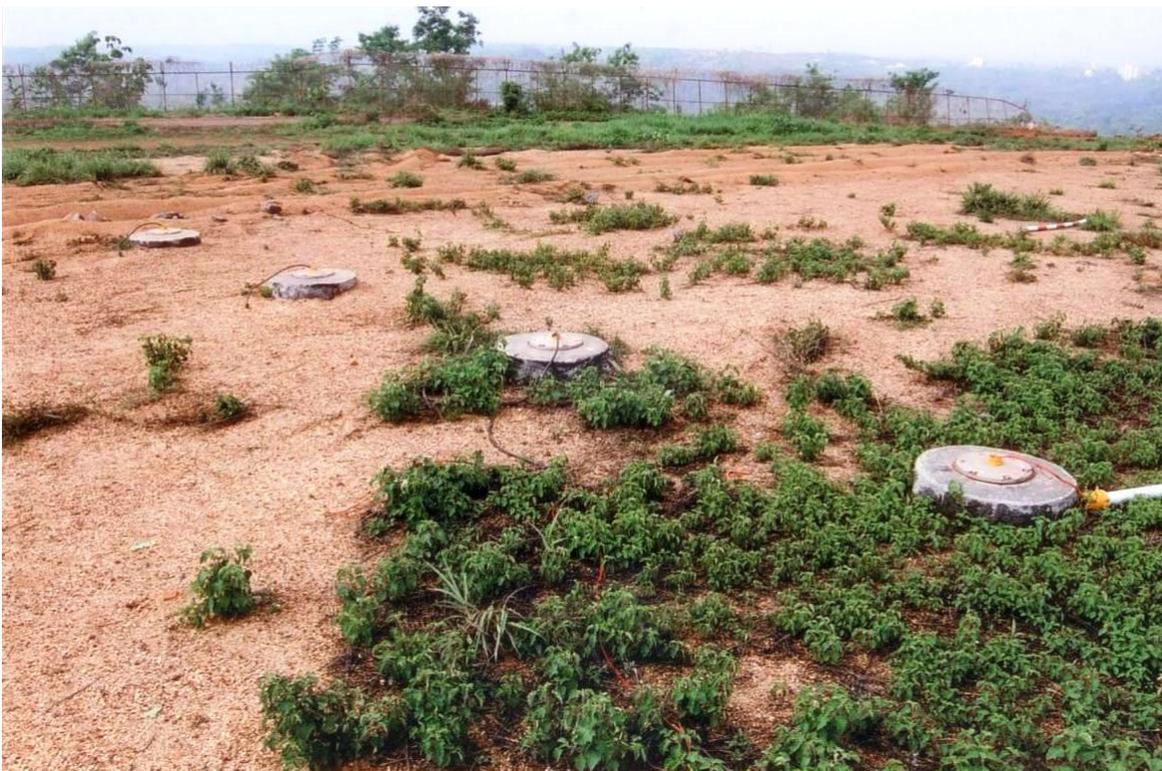
Photo 30: RESA for R/W 24 at Mangalore on the Day of Accident

Inspection of RESA at Mangalore had revealed that at the time of accident, localiser antenna and some temporary concrete platforms for ILS calibration were located within RESA. It also lacked regular maintenance. The RESA did not have adequate sand refilled as the concrete mounting structure of approach lights were protruding above the surface. Also, there were shrubs and vegetation in RESA as evident from the photograph shown below. Regular ploughing of this area would have prevented such growth.
