**REPORT
ON
ACCIDENT TO AIR INDIA EXPRESS BOEING 737-800
AIRCRAFT VT-AXV ON 22nd MAY 2010
AT MANGALORE**

**GOVERNMENT OF INDIA
MINISTRY OF CIVIL AVIATION**

**NEW DELHI
31st OCTOBER, 2010**

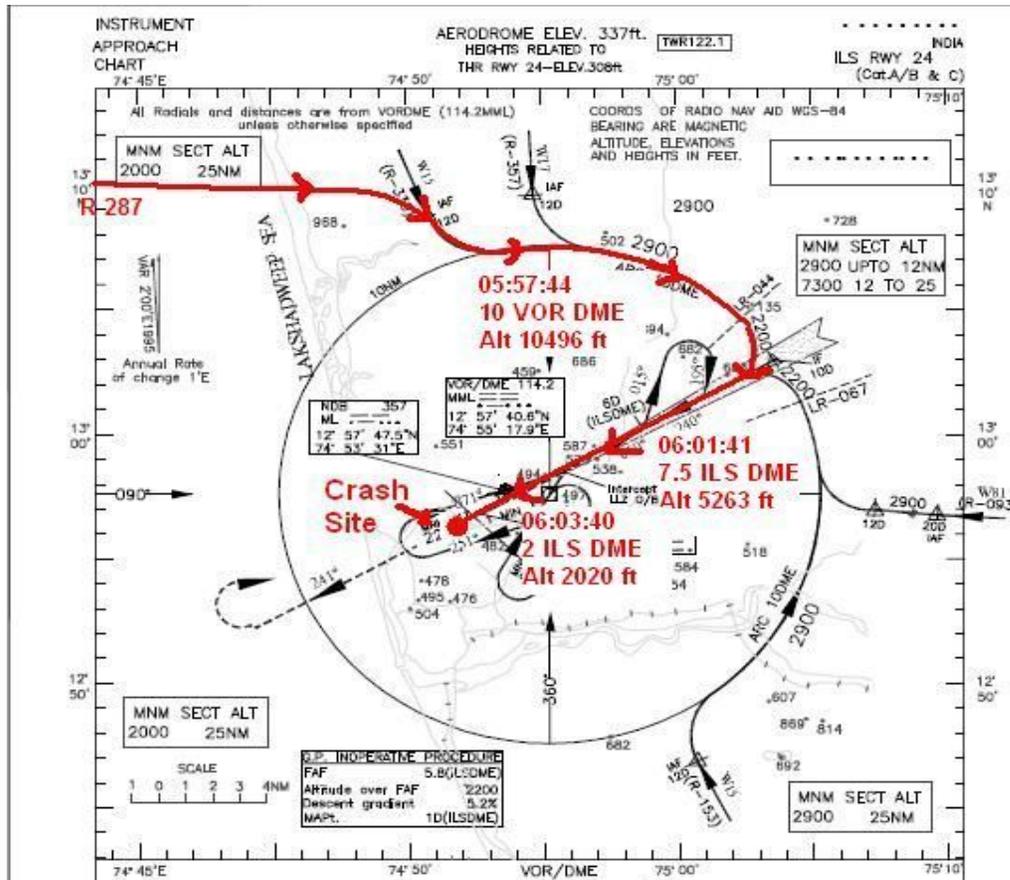
Diagram 2: Plan View of DME Arc Approach Leading to ILS

On having reported 10 DME Arc, the ATC Tower had asked aircraft to report when established on ILS. It appears that the Captain had realised that the aircraft altitude was higher than normal and had selected Landing Gear 'DOWN' at an altitude of approximately 8,500 ft with speedbrakes still deployed in Flight Detent position, so as to increase the rate of descent. As indicated by the DFDR, the aircraft continued to be high and did not follow the standard procedure of intercepting the ILS Glide Path at the correct intercept altitude. This in-correct procedure led to the aircraft being at almost twice the altitude as compared to a Standard ILS Approach.

During approach, the CVR indicated that the Captain had selected Flaps 40° and completed the Landing Check List. At 06:03:35 hours IST at about 2.5 DME, the Radio Altimeter had alerted an altitude of 2500 ft. This was immediately followed by, the First Officer giving a call of "IT IS TOO HIGH" and "RUNWAY STRAIGHT DOWN". In reply, the Captain had exclaimed "OH MY GOD". At this moment, the Captain had disconnected the Auto Pilot and simultaneously increased the rate of descent considerably to establish on the desired approach path. At this stage, the First Officer had queried "GO AROUND?"

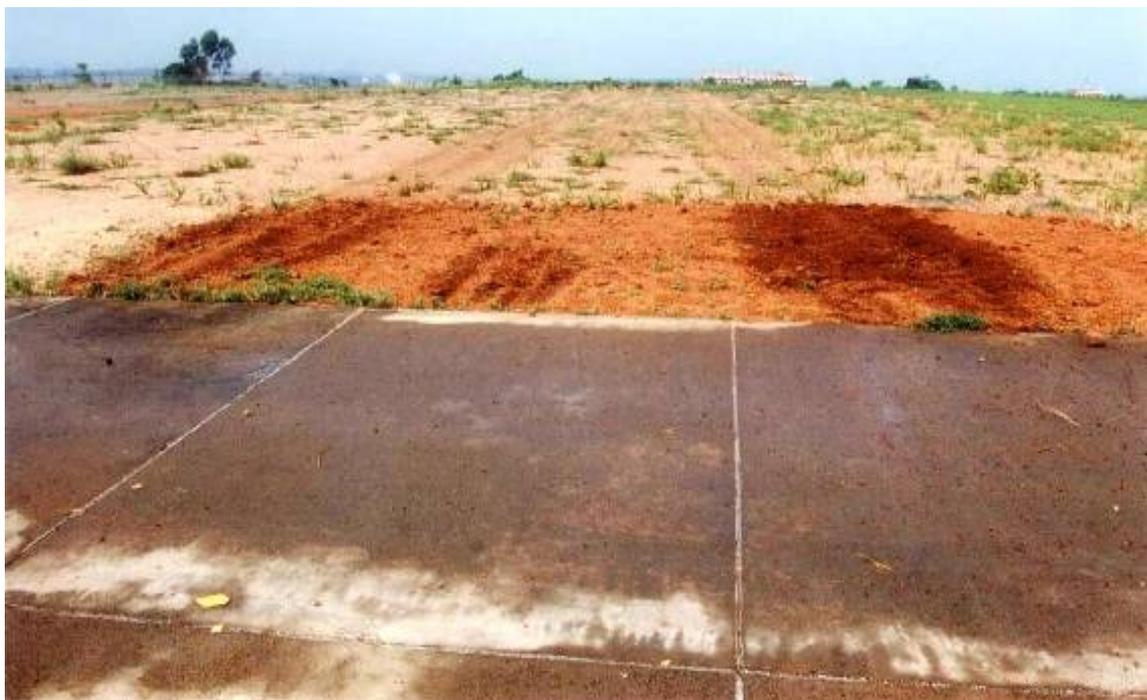
Photo 8: End of Runway 24 (Another View)

At a distance of 235 metres from R/W 24 end, the ILS localiser antenna had been mounted on a concrete structure. The out board portion of the right wing impacted this localiser mounting structure and got separated. The Right wing contacted two left pillars and the extreme left pillar collapsed. The second pillar from left, showed impact damage about 10 feet above ground. Outer portion of the right wing (WBL 616.75 to WBL 680.40) consisting of winglets was recovered at the localiser structure.

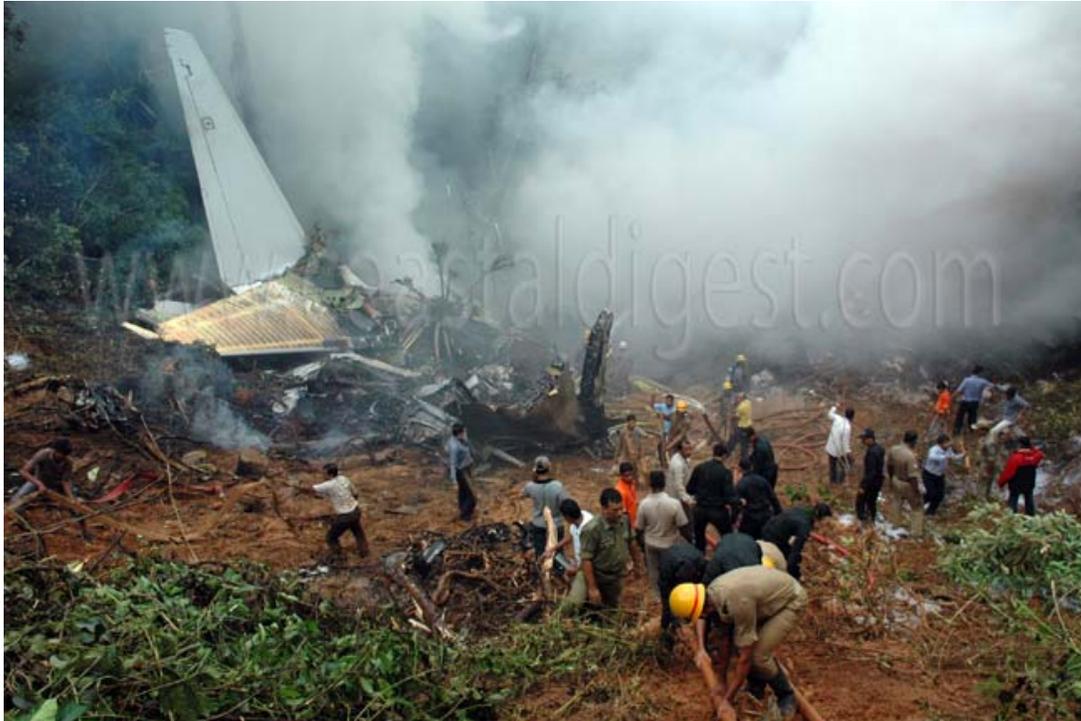
Photo 15: RFF Crew Laying Hoses to Fight the Fire

Emergency Rescue and Fire Fighting response by the RFF Crew of Mangalore Airport was swift. One of the RFF Panther-1 was at the PDP close to the runway and had witnessed the aircraft touching down late. As soon as the aircraft had entered RESA causing the dust to rise, this RFF had rushed behind the aircraft. However, after initial impact with the ILS localiser mounting structure, the aircraft had continued to plough down into the gorge outside the airfield perimeter.

This RFF reached to the edge of the slope close to airfield perimeter and tried to throw water and foam towards the aircraft. But, the crash site was out of its range. It, therefore, extinguished fire of all parts of the right wing, which had broken off after the impact with ILS structure.

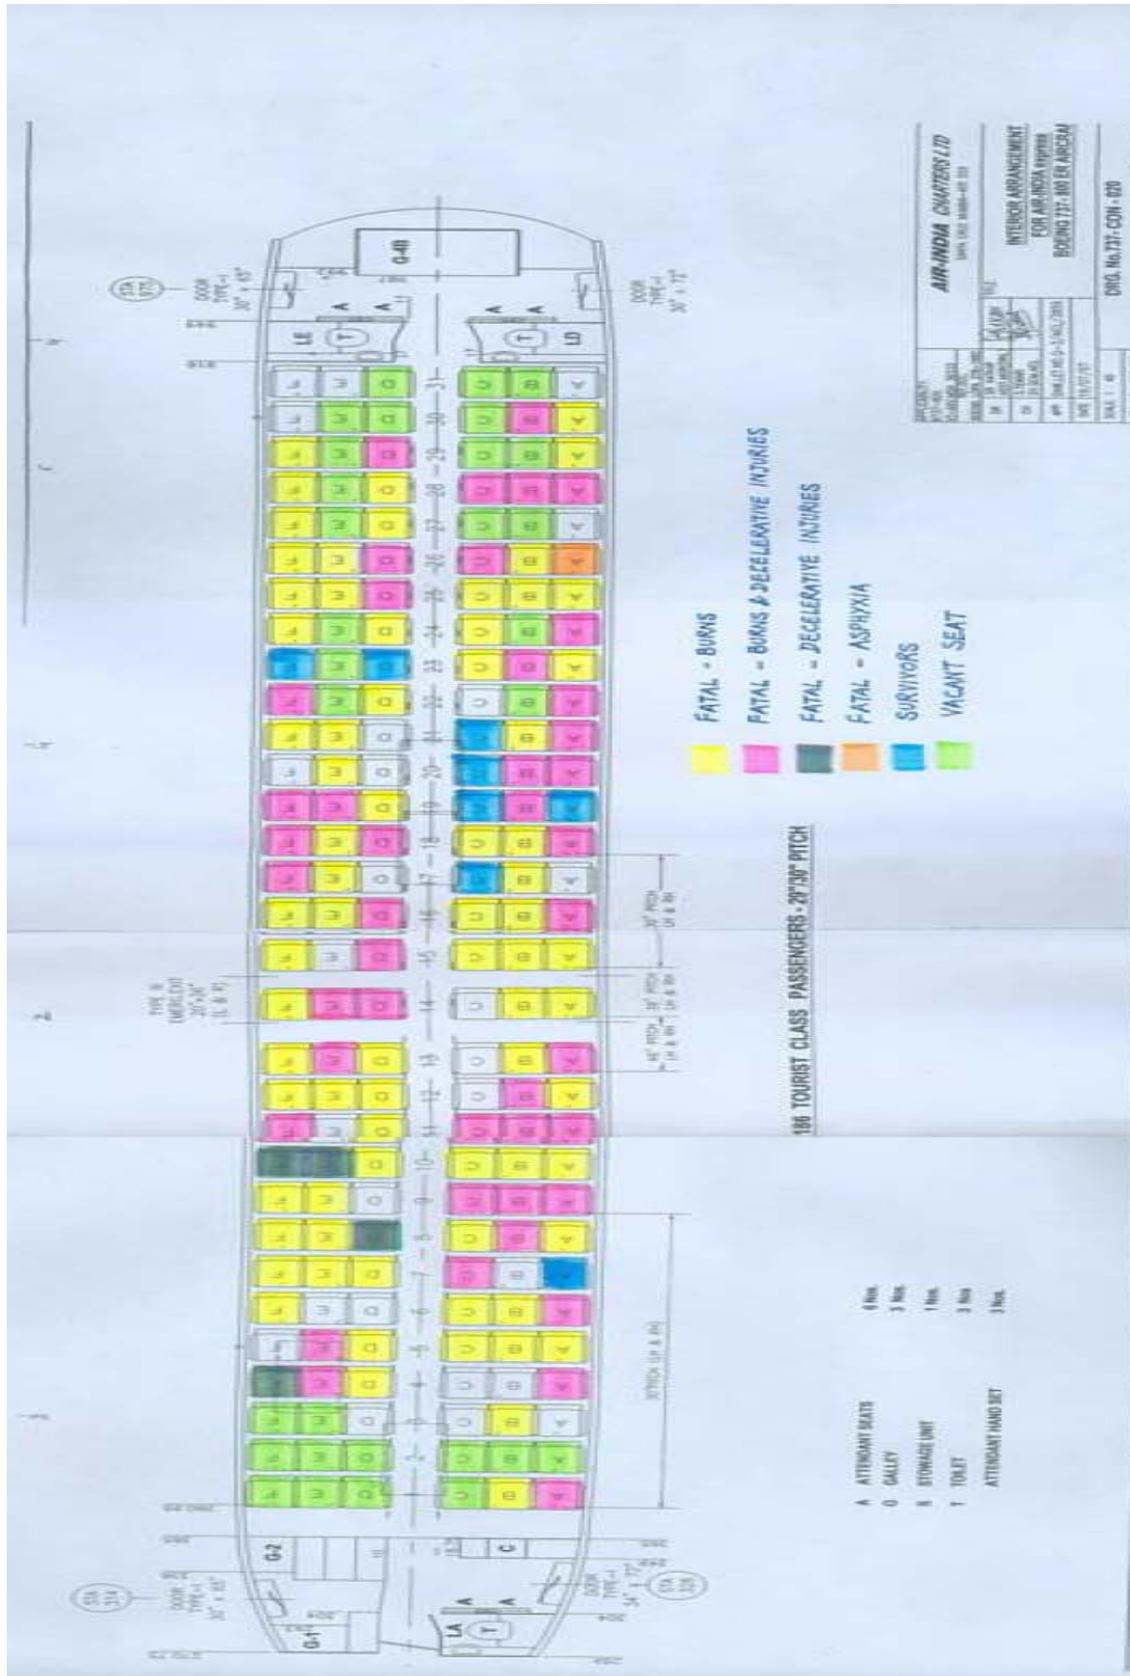
Diagram 11: LOPA of the Accident Aircraft

There were a total of 8 survivors who had occupied seats as shown in the Layout of Passenger Accommodation (LOPA). These survivors had occupied the seat No 7A, 17C, 19A, 19C, 20C, 21C, 23D & 23F. It could be seen that there was no specific pattern of seating, which helped in survival. All the eight survivors were occupying seats in different rows and not necessarily along the window or aisle. Of these, most were grouped from seat rows 17 to 23 and only one was ahead at 7A. However, it was to their good fortune that the aircraft broke into 3 main portions which allowed them to jump out of the openings mainly to the left since the aircraft had tilted to the right when it finally came to rest.

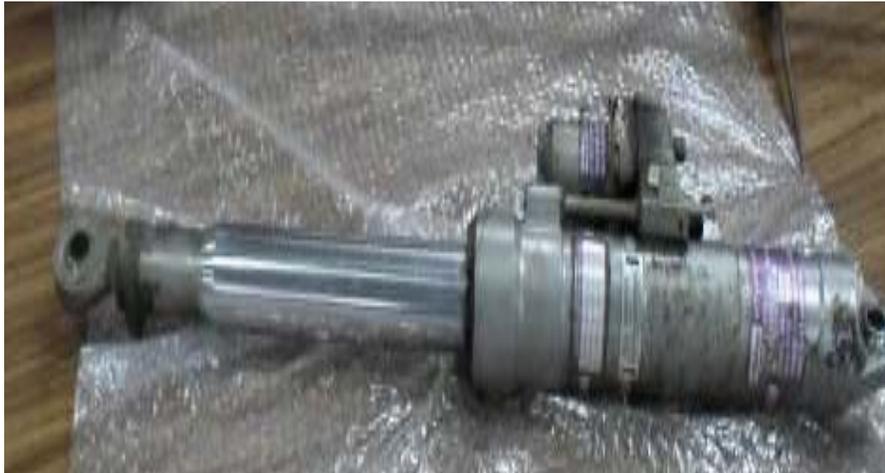
Photo 17: Leading Edge Flap Actuator

Part Number	382000-1001
Serial Number	10161
Position	# 2.
CMM	27-80-05
Total length	“L” :- 26.2 Inches (Between bearings centre)
Findings	(a) Actuator position - extended corresponding to flap extended. (b) Physical condition is ok. (c) No parts missing.

All the Leading Edge Flap / Slat actuators were found in the extended position, which correspond to the flap lever position of 40°. Therefore, it could be concluded that all Leading Edge devices had operated as per the cockpit input.

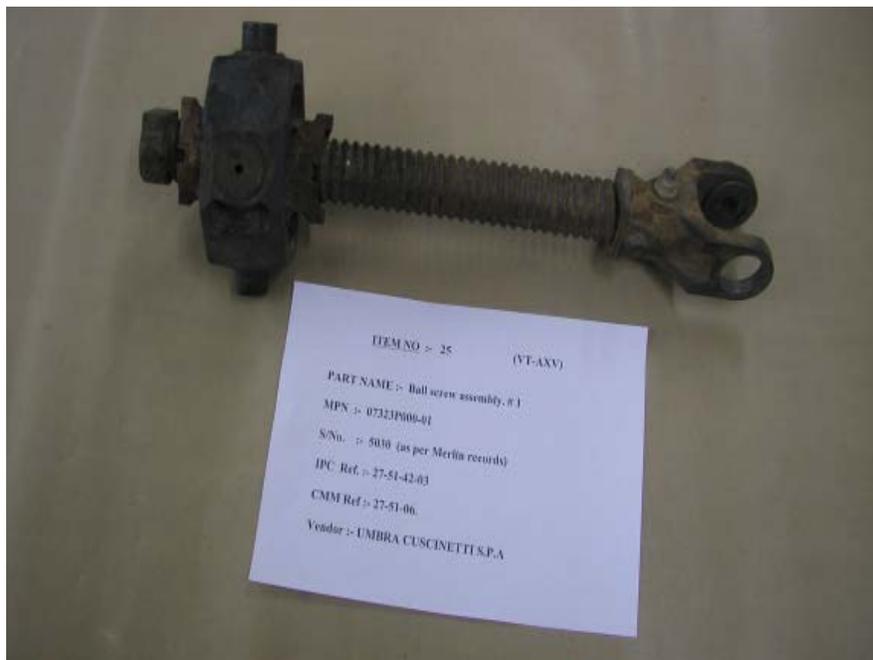
Photo 20: Trailing Edge Flap Ball Screw

Part No.	07323P000-01
Serial No.	5030
IPC Ref.	27-51-42-03
Total length	"L" :- 20.00 Inches (stop end to Centre of yoke end bushed hole)
Findings	(a) Ball nut & Gimbals assy. found in flap fully extended position

Flap handle was found in the 40 detent. Trailing Edge Flap Jack Screws were found in the fully extended position, which corresponded to the fully extended position of the flap. From DFDR data, it was seen that flap lever and the flap surface were in 40 degree position in flight from 06:03:23 to 06:04:16 hours IST. Thereafter, while the flap lever continued to remain in the 40 detent, the surface had retracted to 30 degree between 06:04:17 and 06:04:37 hours IST due to increase in speed of the airplane. Flap surface was again extended to 40 degrees from 06:04:38 hours IST till the time of the accident. From the above, it could be implied that Flap system had responded correctly to the commands.

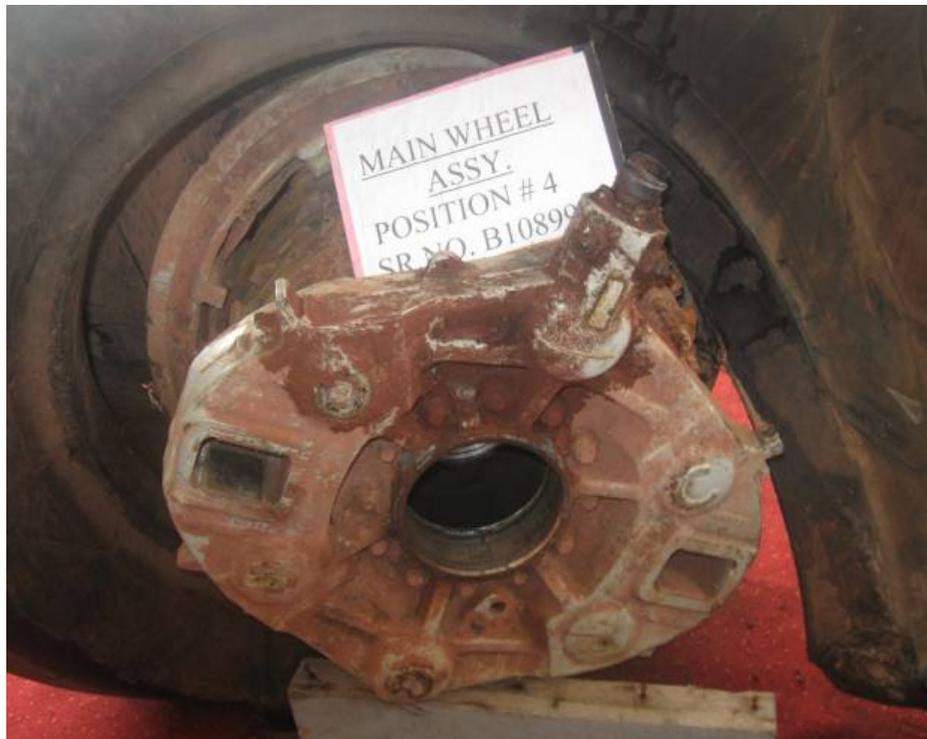
Photo 28: Main Wheel and Tyre Assembly

Part No.	277A6000-204	277A6000-204	277A6000-204	277A6000-204
Serial No.	B9061	B14941	B8266	B10899
Position	# 1	# 2	# 3	# 4
Date of Installation	07.05.2010	18.04.2010	01.05.2010	18.05.2010
Landings done	63	135	79	14
Tyre Findings	a) Deep cut noticed at 2 locations on sidewall. b) Burn marks noticed on tread area approx 2 feet by 10 inch on crown area. c) Wheel assy. Holding 30 PSI pressure	Tyre found burst and burn at about ¾ of tyre crown area	a) Tyre burst b) Tyre found damaged at four locations c) Tyre cut noticed about 4 feet due to burst towards I/B side	a) Brake and wheel found jammed b) Tyre burst c) Burn marks noticed on tread area approx 2 feet by 10 inch on crown area
Hub Assembly Findings	a) All tie bolts found intact b) All fusible plugs found intact c) No damage noticed on heat shields and keys d) Pressure relief valve found intact e) Wheel bearing and seal found intact f) No damage noticed on I/B and O/B HUB externally	a) All tie bolts found intact b) All fusible plugs found intact c) No damage noticed on heat shields and keys d) Pressure relief valve found intact e) Wheel bearing and seal found intact f) Minor Damage noticed on I/B and O/B HUB externally	a) All tie bolts found intact b) All fusible plugs found intact c) Minor damage noticed on heat shields and keys d) Pressure relief valve found intact e) Wheel bearing and seal found intact f) No damage noticed on I/B and O/B HUB externally.	a) All tie bolts found intact b) All fusible plugs found intact. c) No damage noticed on heat shields and keys d) Pressure relief valve found intact e) Wheel bearing and seal found intact f) Minor damage noticed on I/B and O/B HUB externally.

The analysis of the Main Wheel showed no pre-existing defects. Three tyres were burst due to post impact damage. Number 1 Wheel Assembly, which was intact, was holding 30psi pressure at the time of examination.

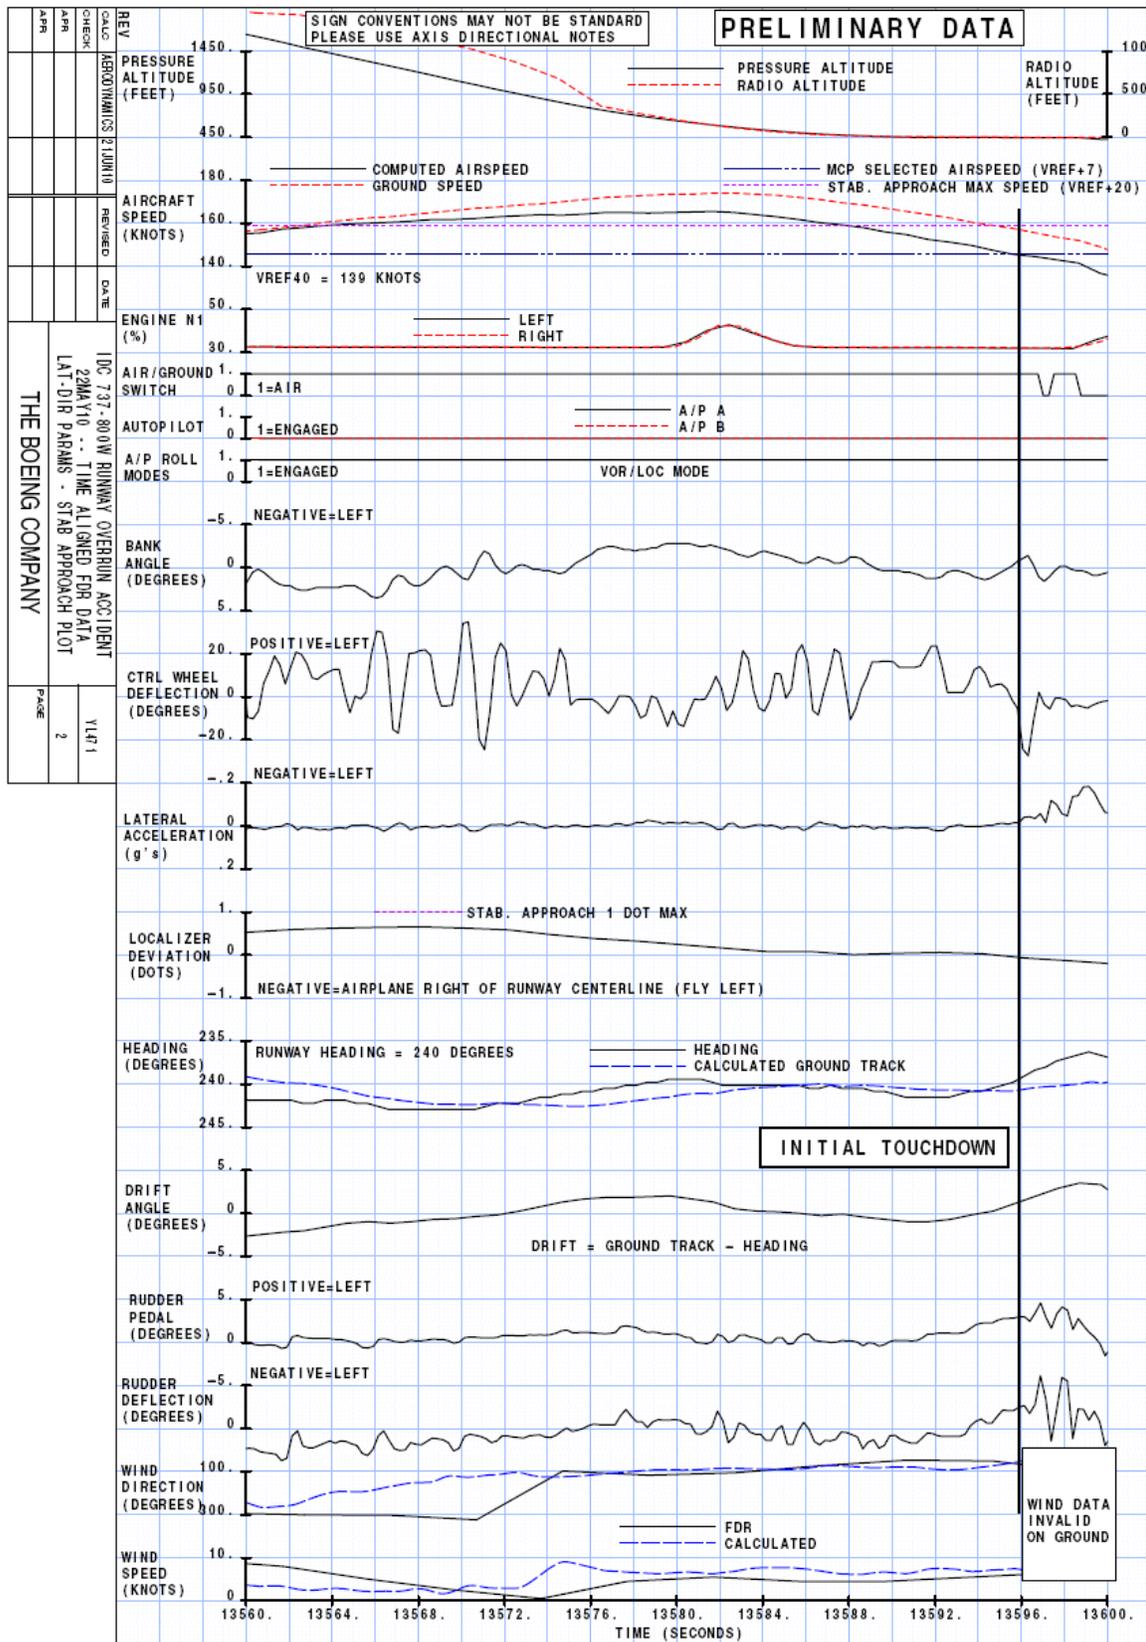
Figure: 2

The ILS approach criterion states "ILS and GLS approaches should be flown within one dot of the glide slope and localizer, or within the expanded localizer scale." Figure 2 shows the airplane was within one dot of the localizer all the way through the approach, but Figures 1 and 3 shows the airplane was not within one dot of a 3-degree glide slope.

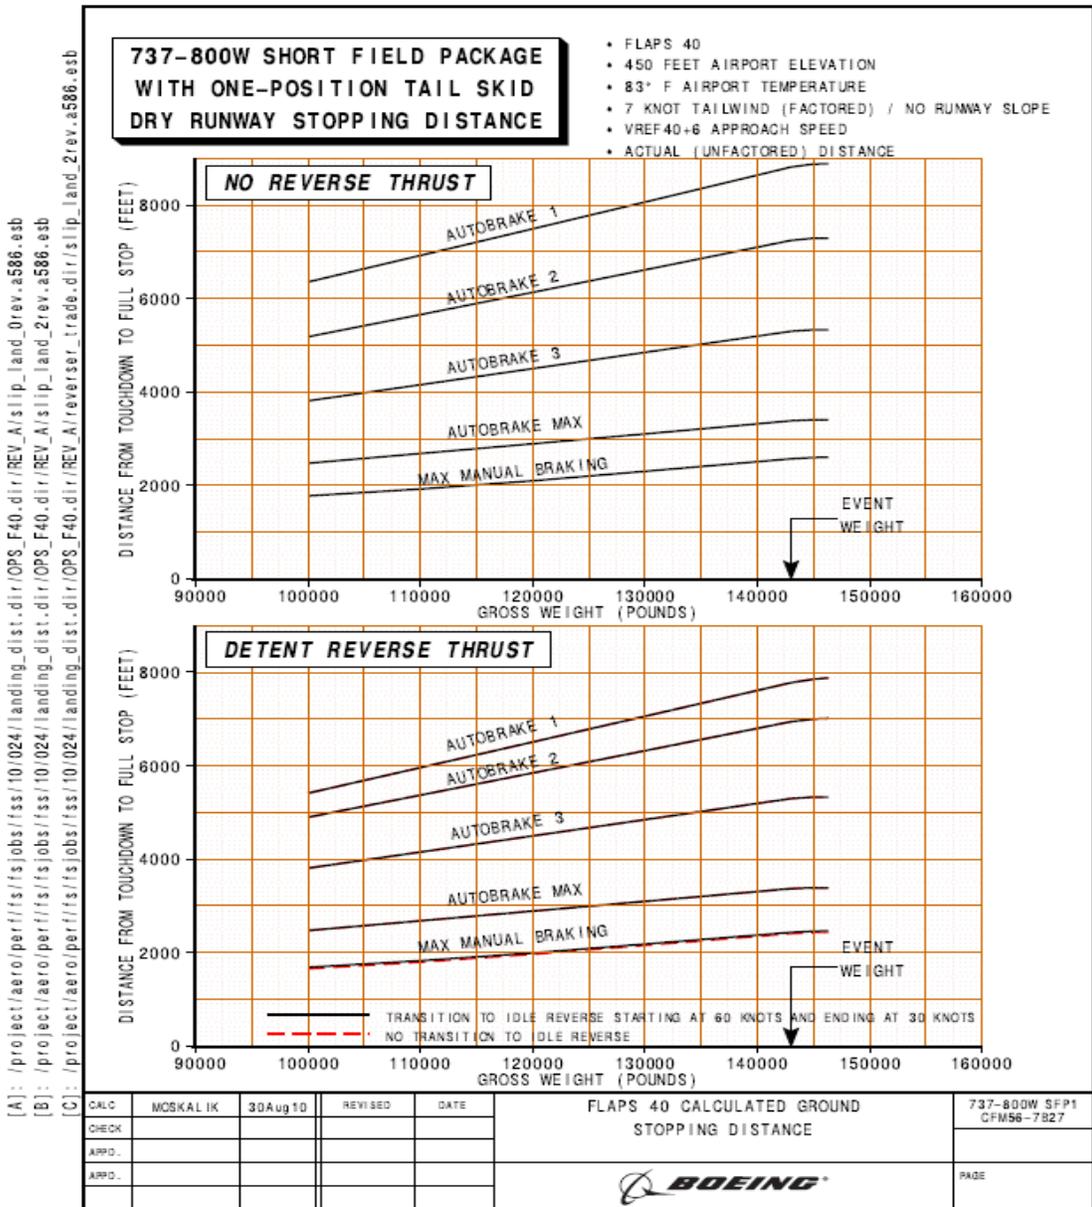
Figure: 8

The airplane does have adequate stopping performance to come to a complete stop on the improved surface available using a dry runway assumption. Based on the data from Figure 8 (described in the next paragraph) and the event airplane's weight (~143,000 pounds), the airplane could stop in approximately 2400 feet with the following assumptions: max manual braking, detent reverse thrust, Speedbrakes deployed, and reverse thrust maintained until fully stopped. Since the airplane's final touchdown point was approximately 5200 feet from the Runway 24 threshold, the airplane could have come to a complete stop at 7600 feet from the threshold (438 feet of runway remaining).

Figure 8 includes two plots showing airplane stopping capability. The upper plot assumes no reverse thrust, and the lower plot assumes detent reverse thrust. On both the upper and lower plots there are lines for auto brake settings of 1, 2, 3, and max along with maximum manual braking. The vertical scale shows the distance from touchdown to a complete stop. Transition from touchdown to full braking assumes: brake initiation (auto brakes) at touchdown (manual braking is one second after touchdown), speed-brake select one second after touchdown, and reverse thrust (if applicable) select one second after spoiler select. No flare distance is included.

The conditions are labelled in Figure 8 and are meant to reflect the actual conditions of the event: Flaps 40, 450 feet pressure altitude, 83° F outside air temperature, touchdown speed of VREF40+6 knots and a reported 7 knot tail wind. The wind value was conservatively factored by 1.5, so that the calculation assumed a 10.5 knot tailwind. This is consistent with the Airplane Flight Manual and FCOM calculation method. In addition, all airplane parameters used in the calculation are consistent with the databases used to develop the airplane flight manual and operational performance data provided in the FCOM.
